## Leakage Detection Survey Report

Report Ref: LD2901

**Site Address:** 94 Ashridge Road, Wokingham, Berkshire, RG40 1PH

Reports of water damage to the wall of the hallway and suspected leak to be the cause.

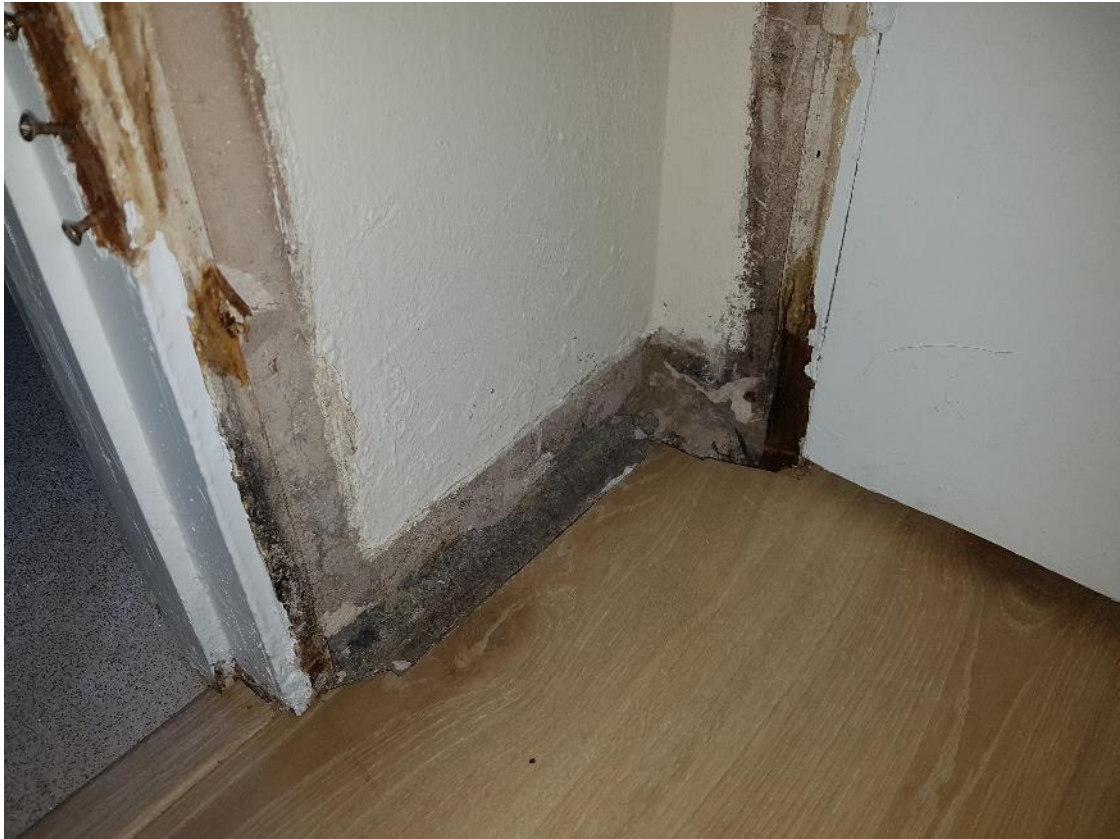
Affected area of the hallway

- (1) Drying focused on the one area of the doorway.
- (2) Access to the flat above was offered by the home occupier however when we attended nobody answered the door, an inspection within this property should be undertaken.

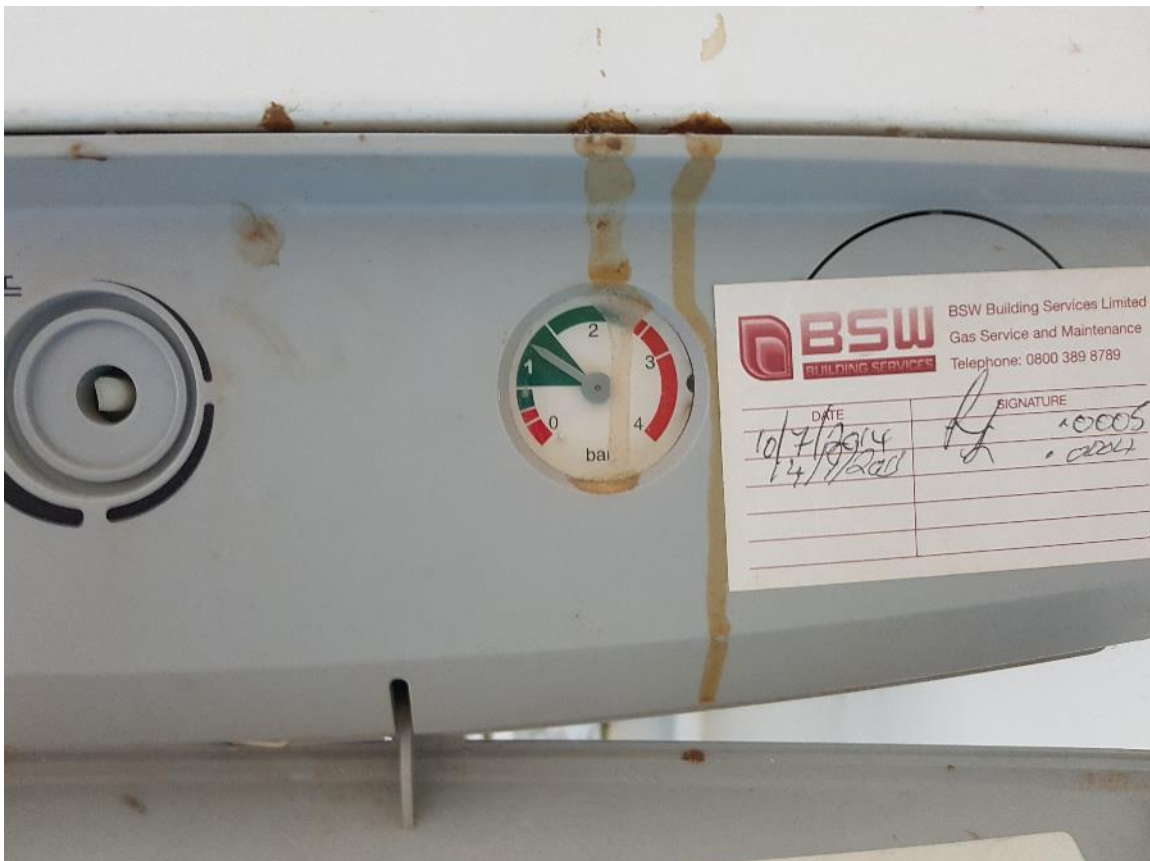
Heating pressure stable

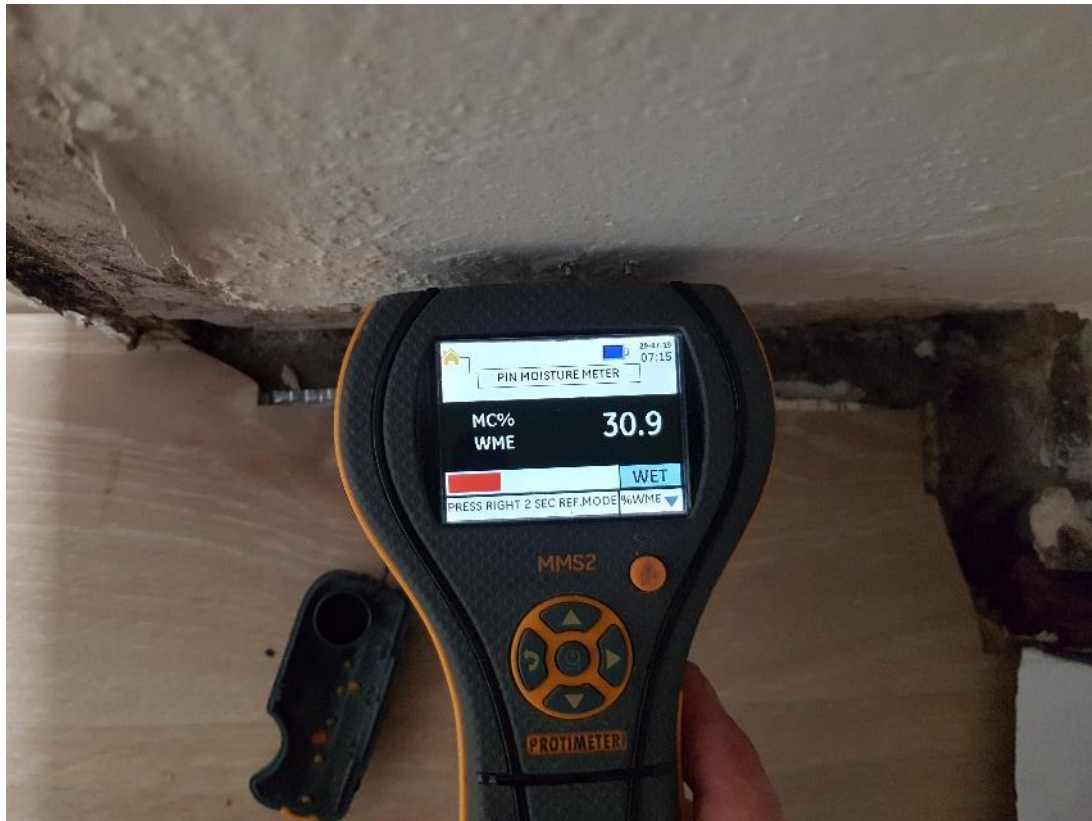
Moisture readings

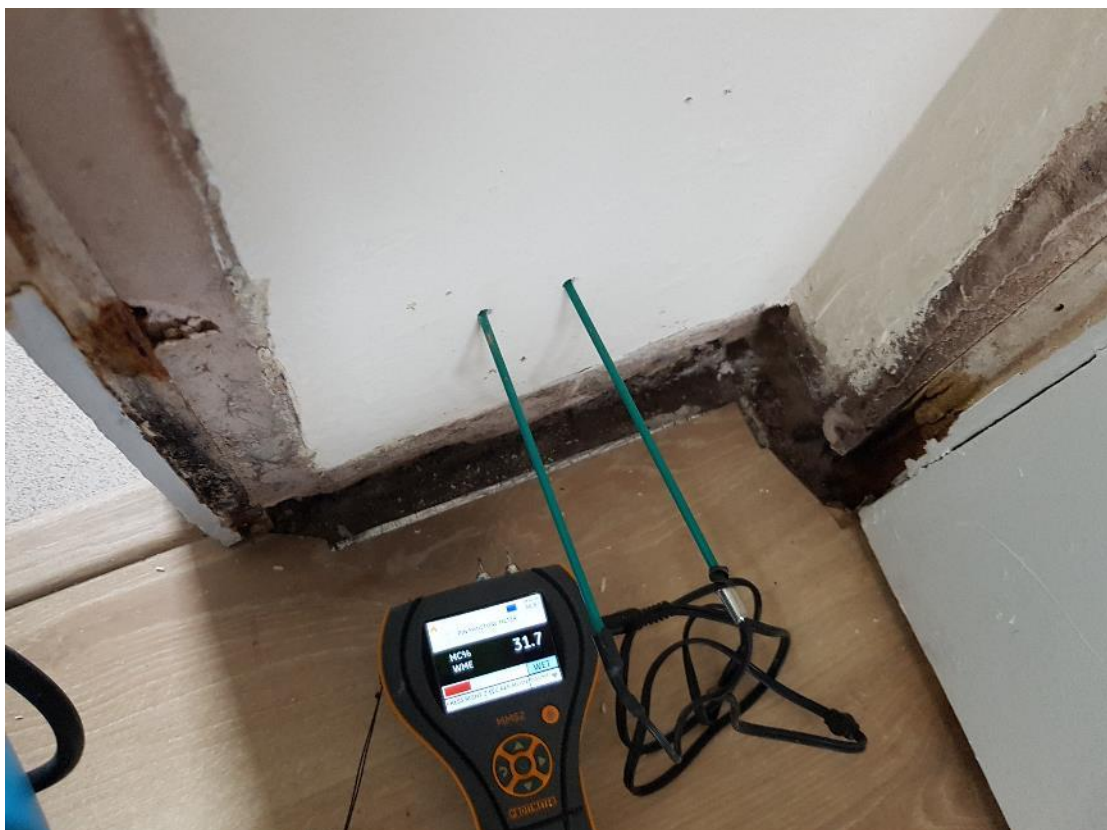
In depth readings

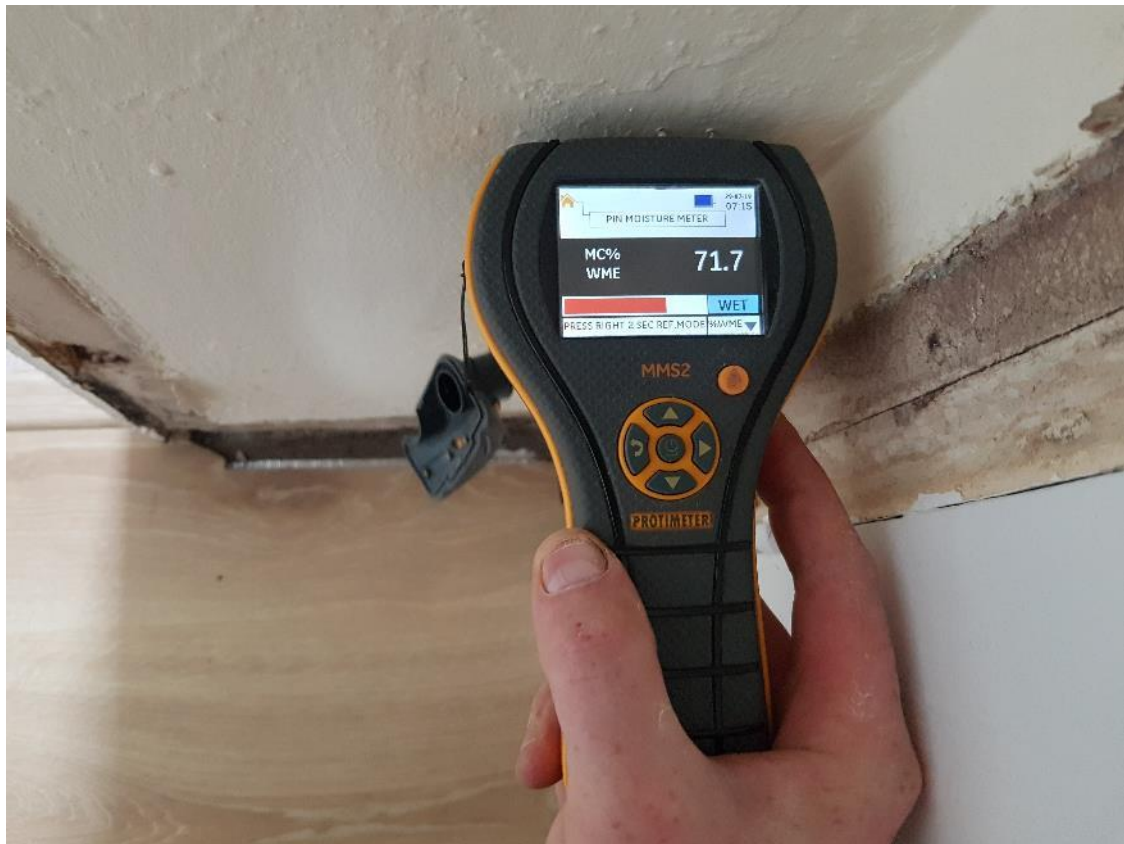
Mid-level

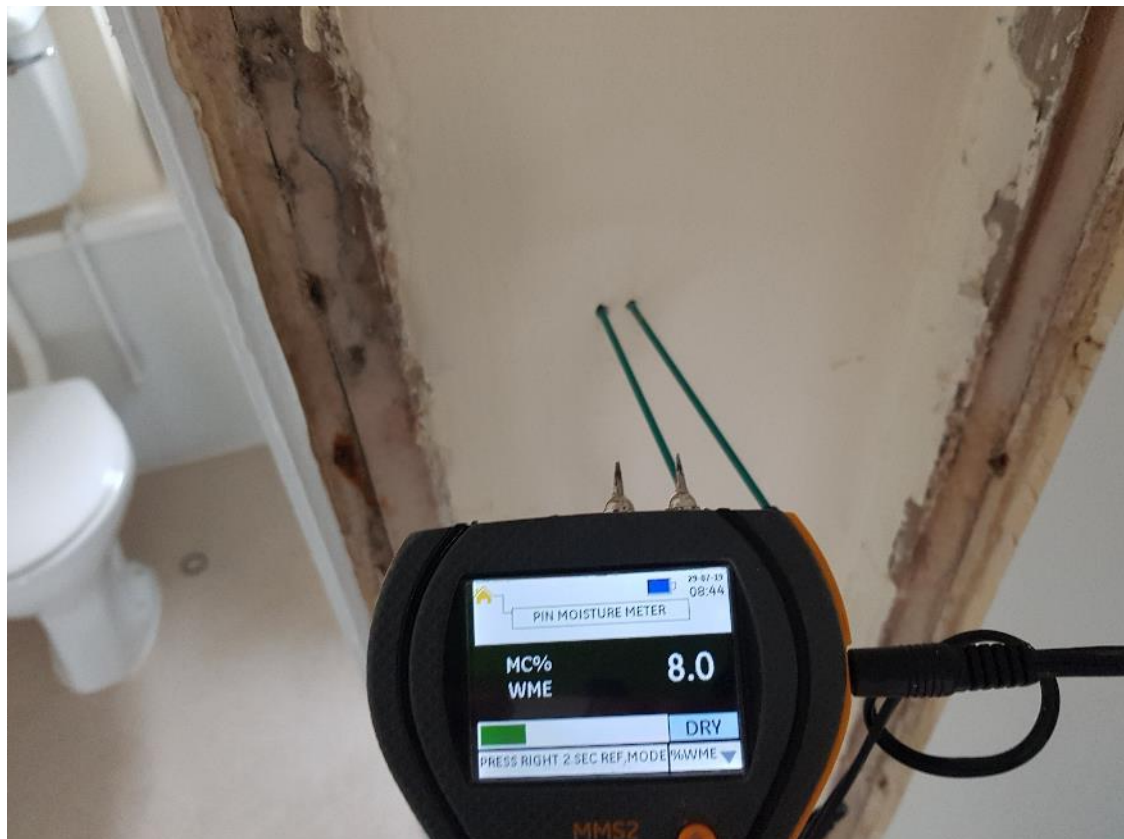
In depth readings

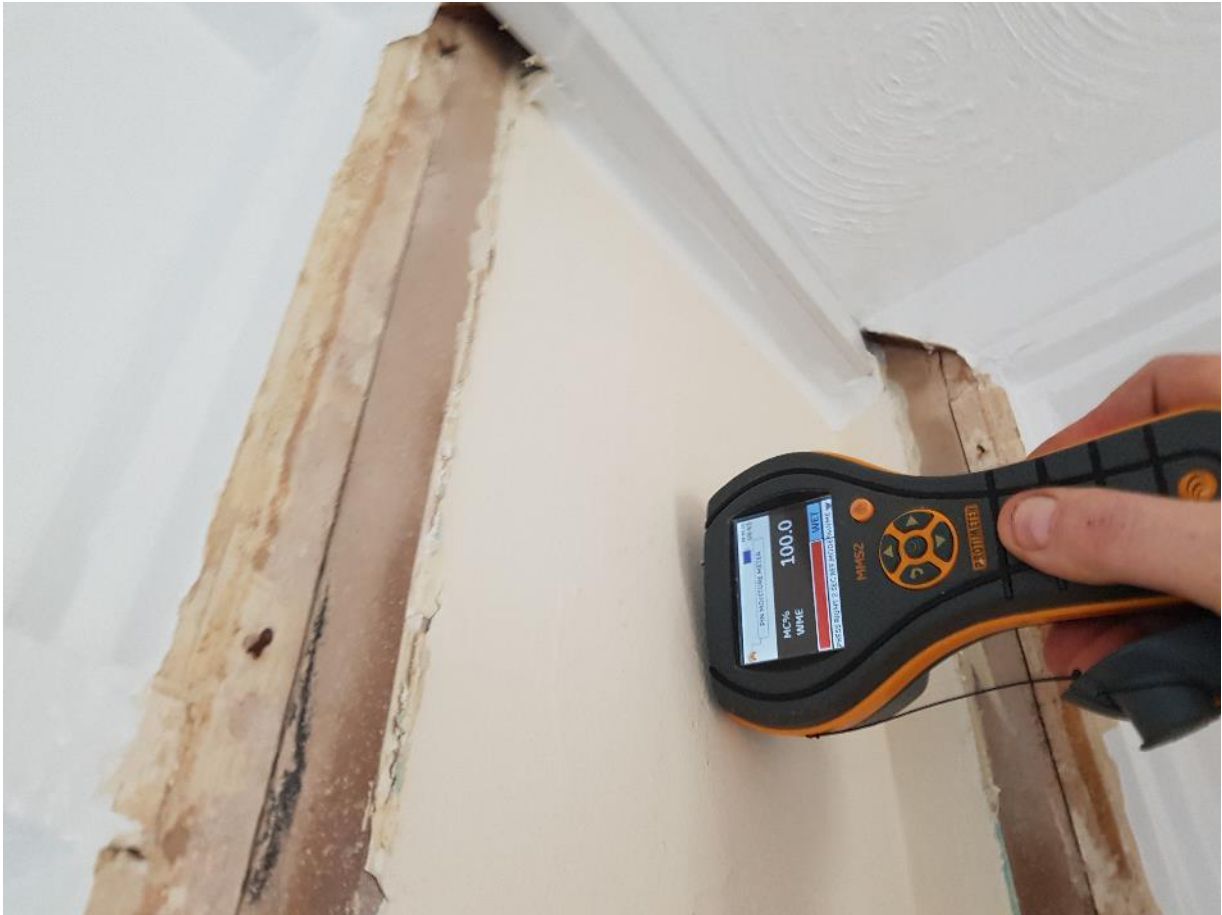
High level

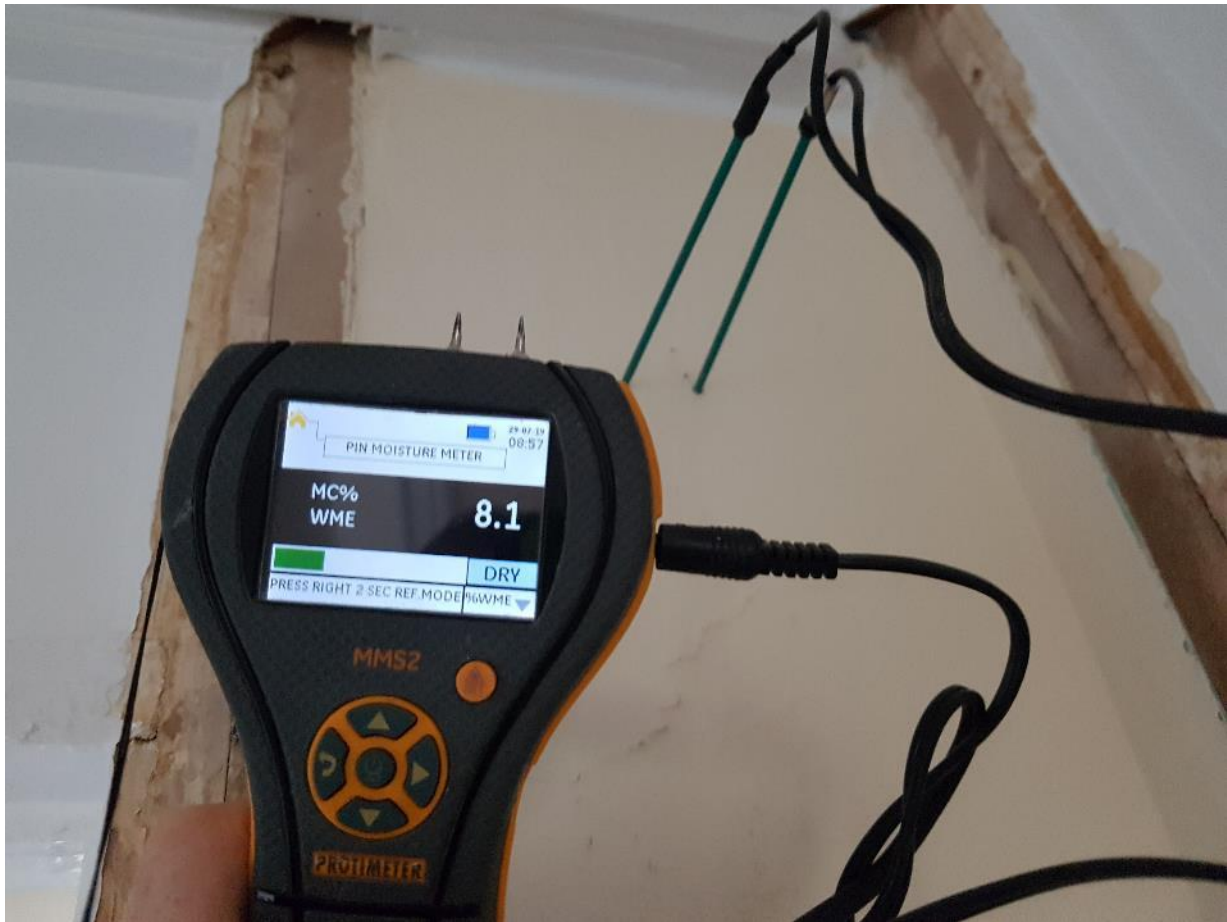
In depth readings

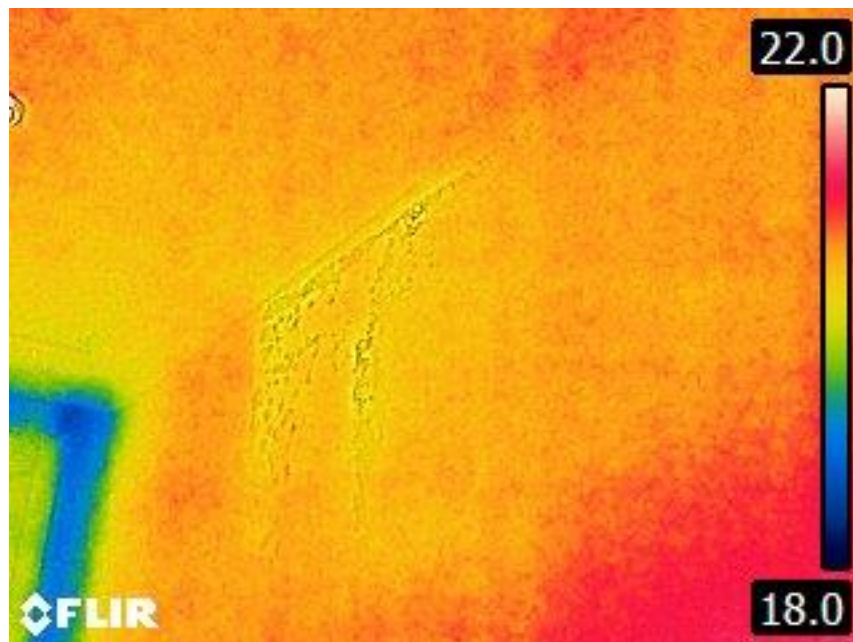
Thermal imaging

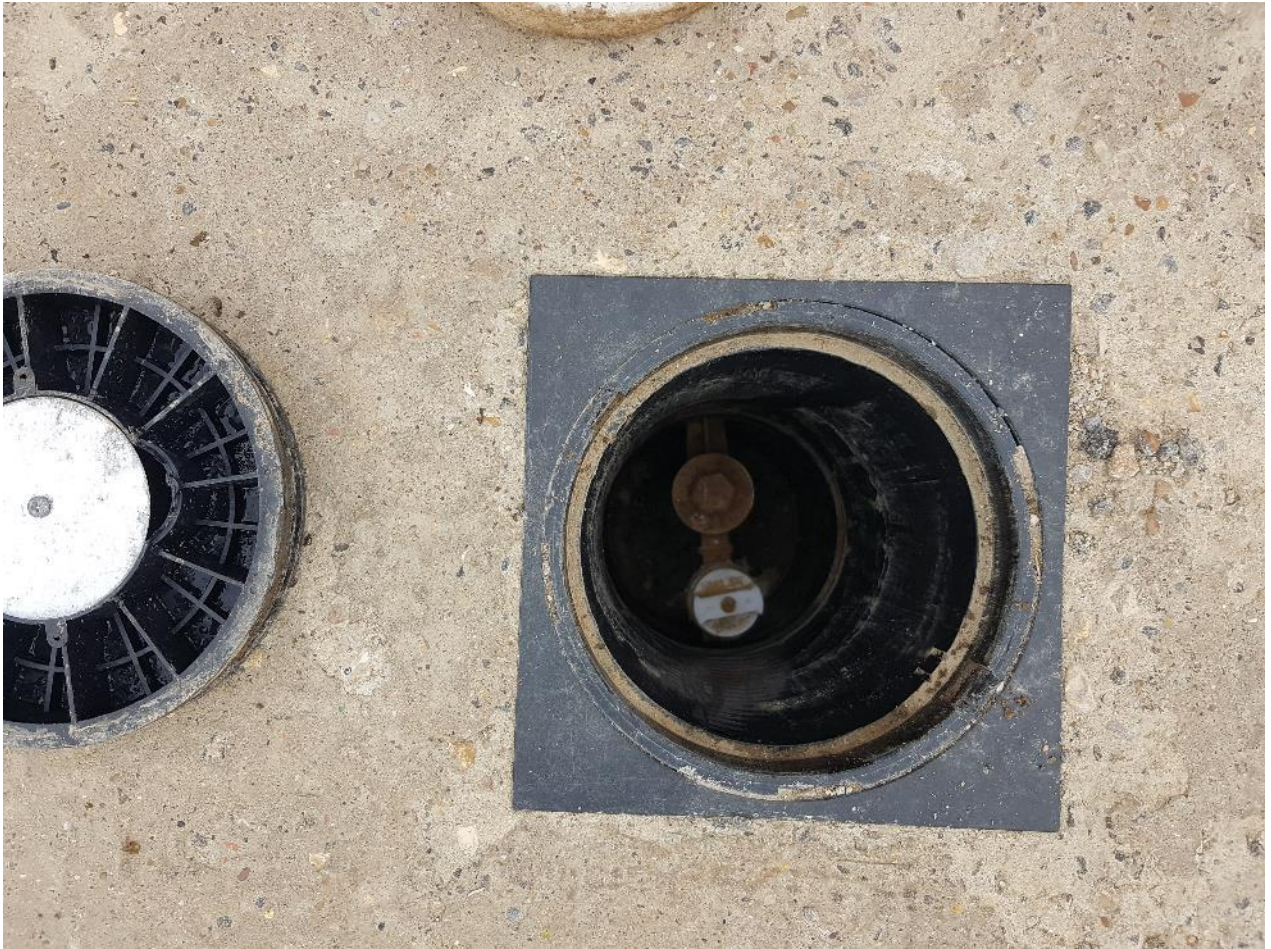
No water meters

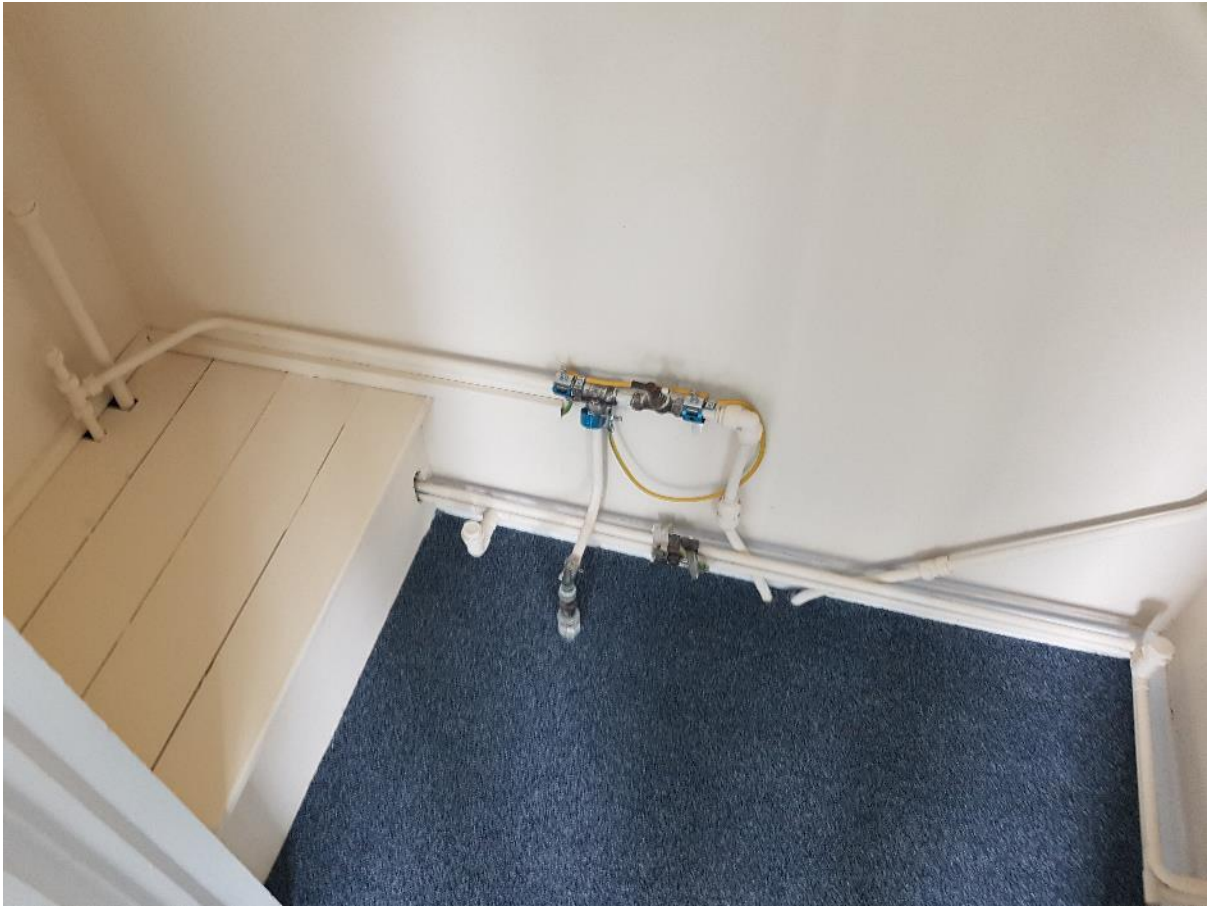
Incoming supply here

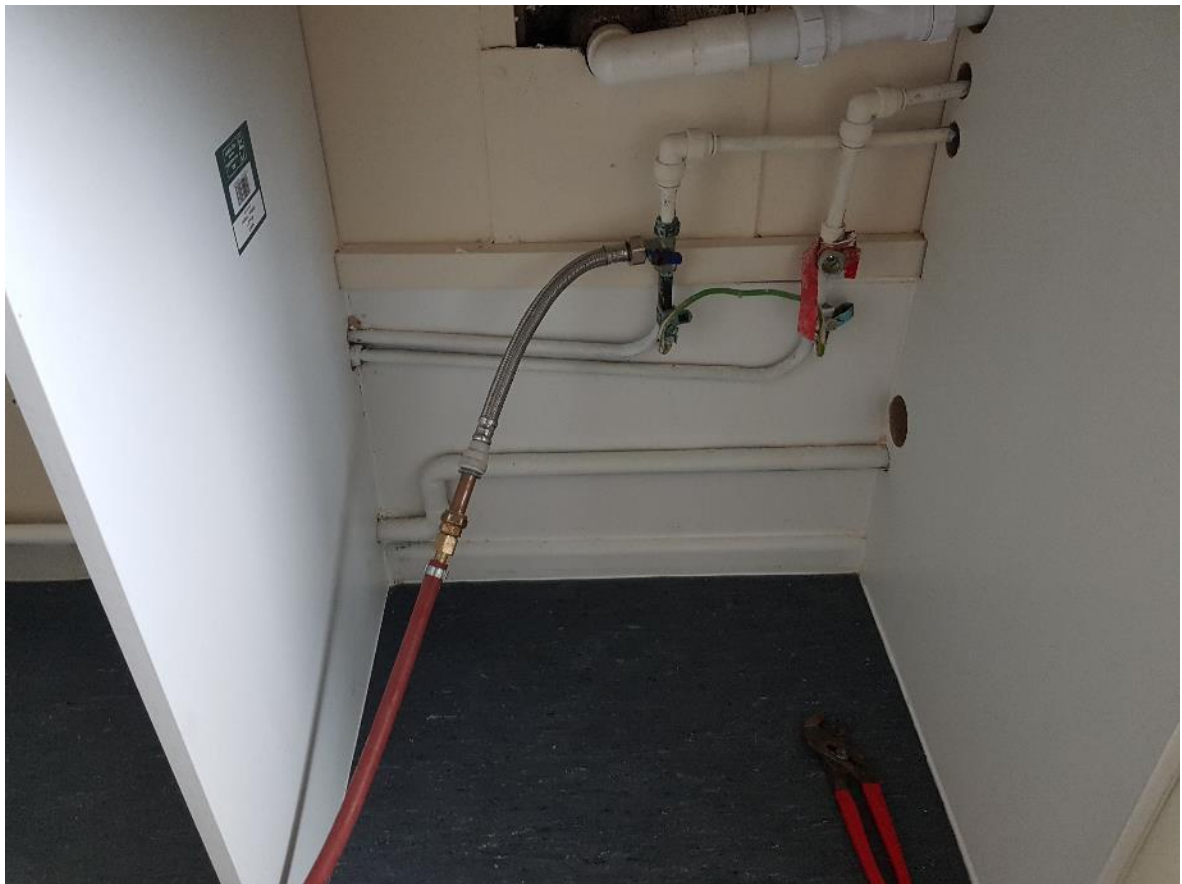
Tracer gas inserted here

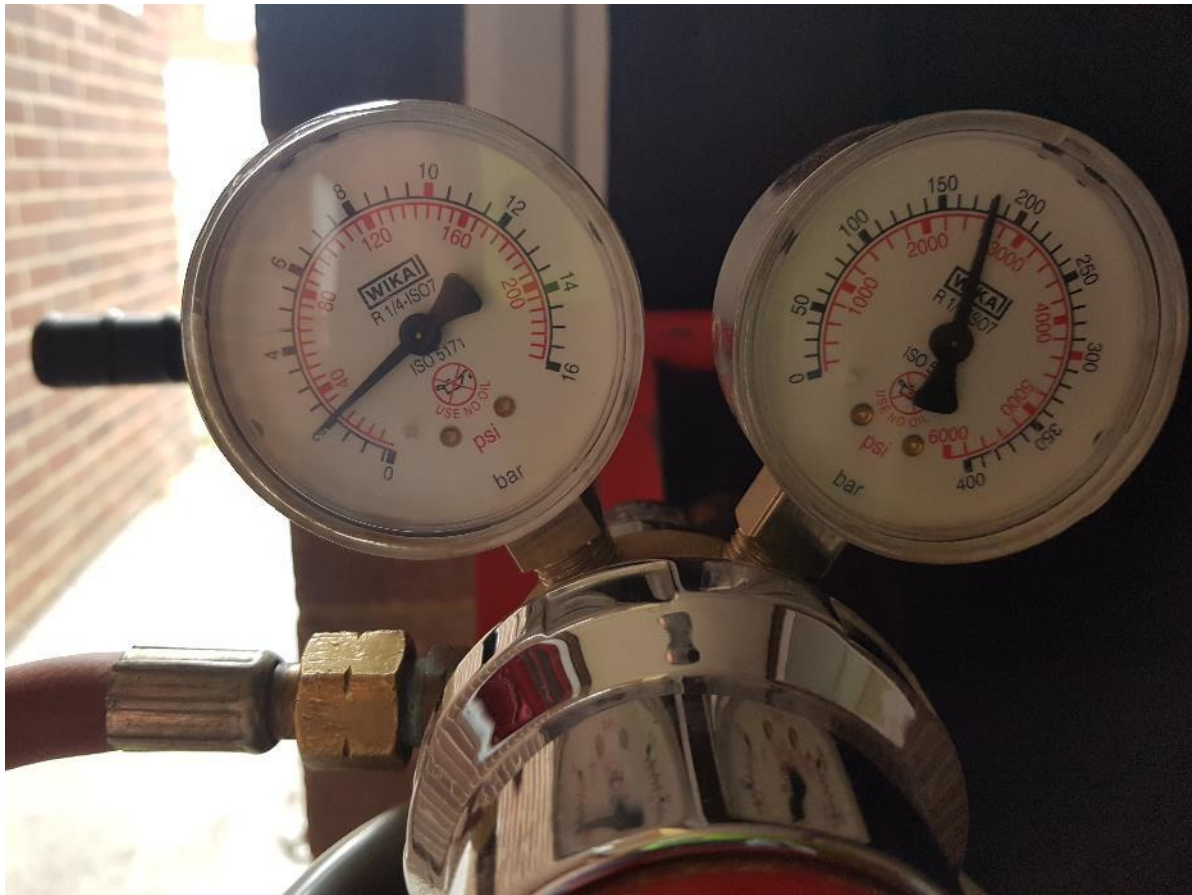
Tracer gas used

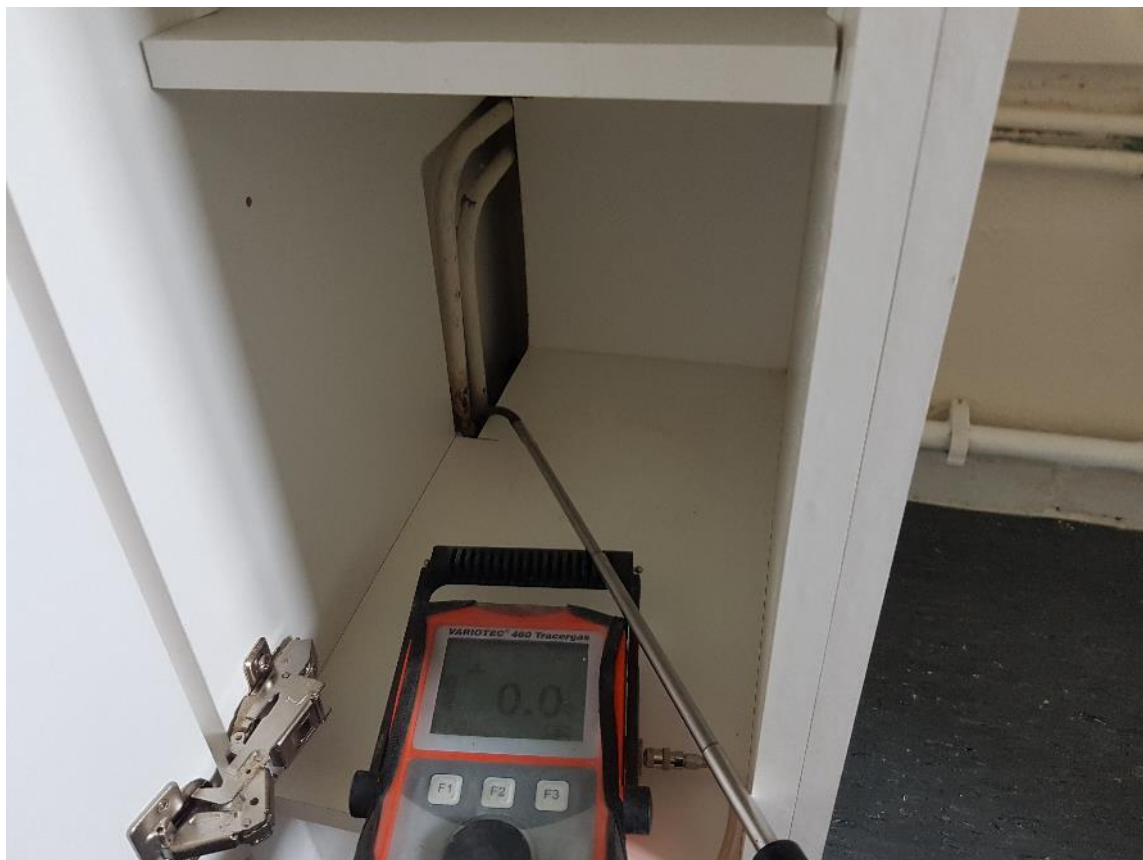
Searching for tracer gas

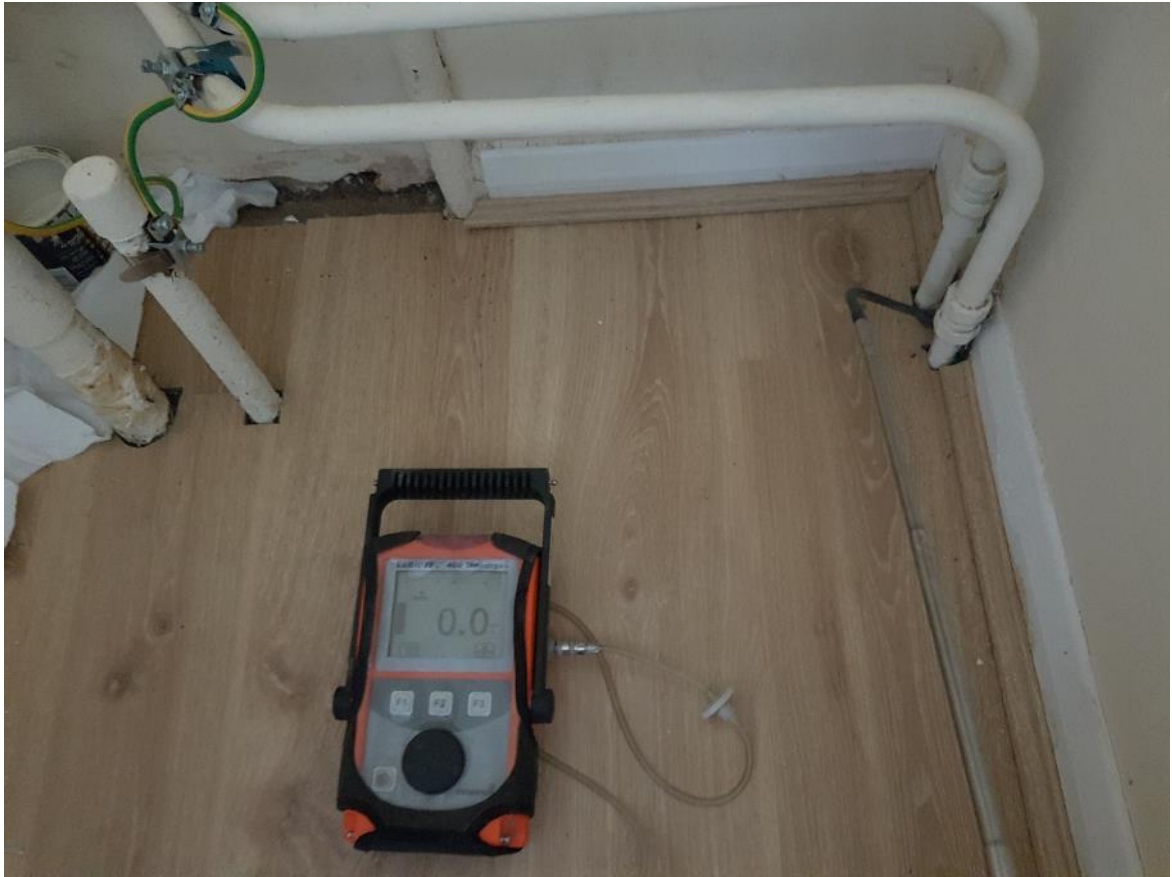
No tracer gas found

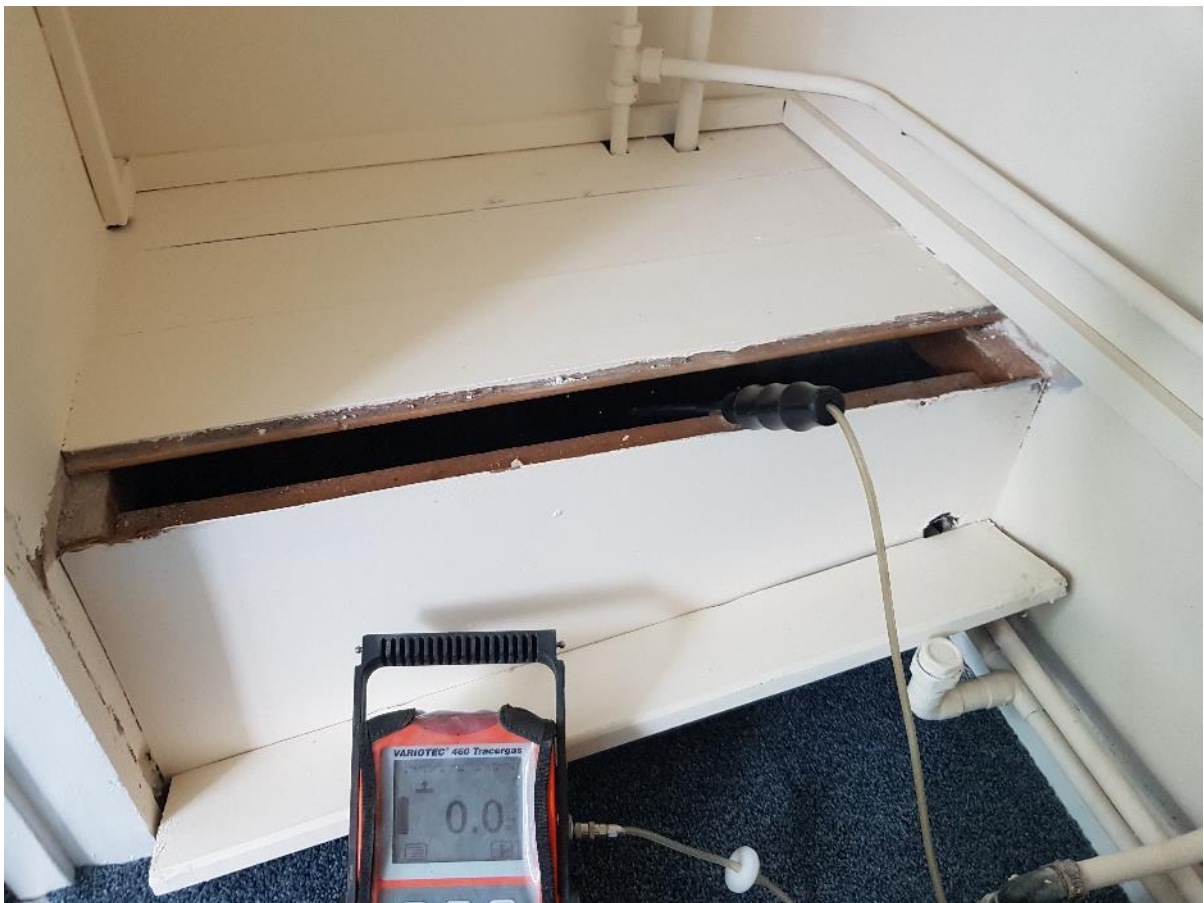
As above

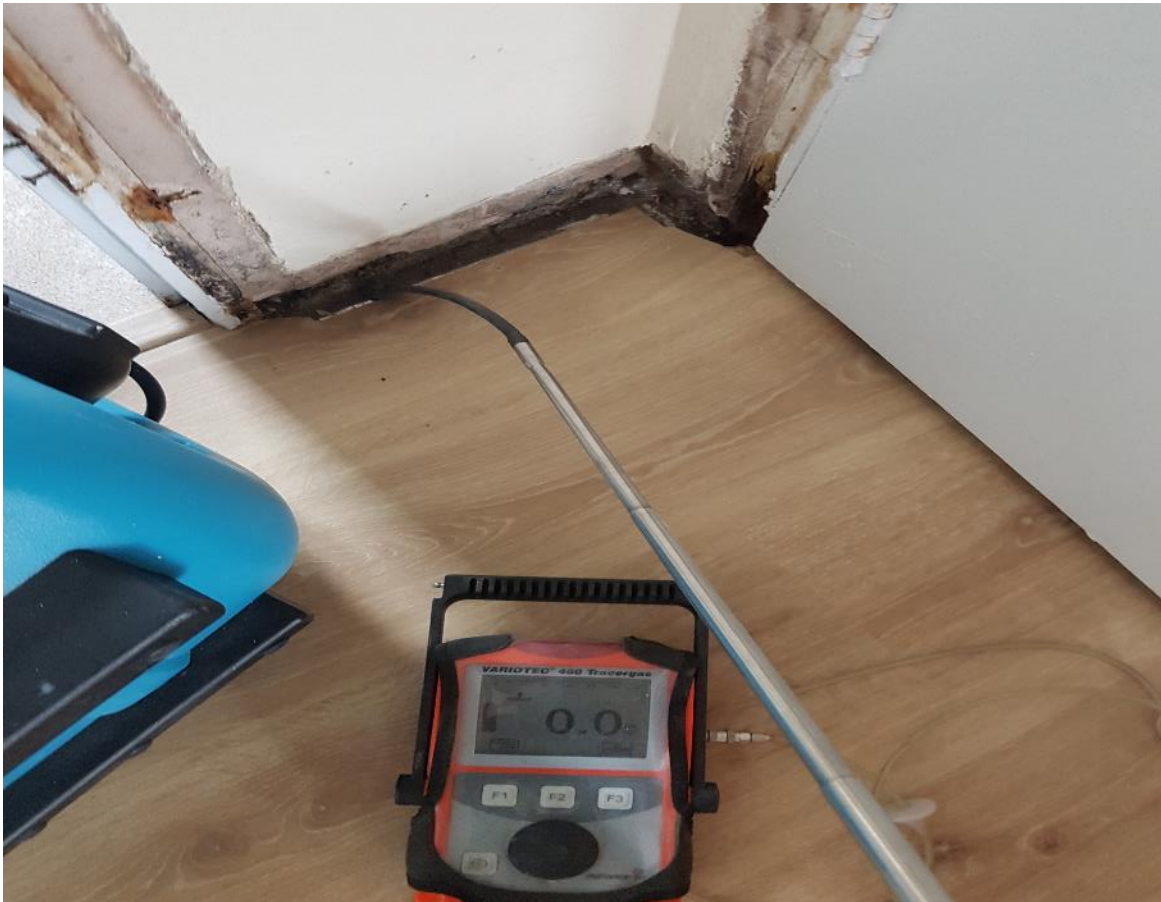
No tracer gas found

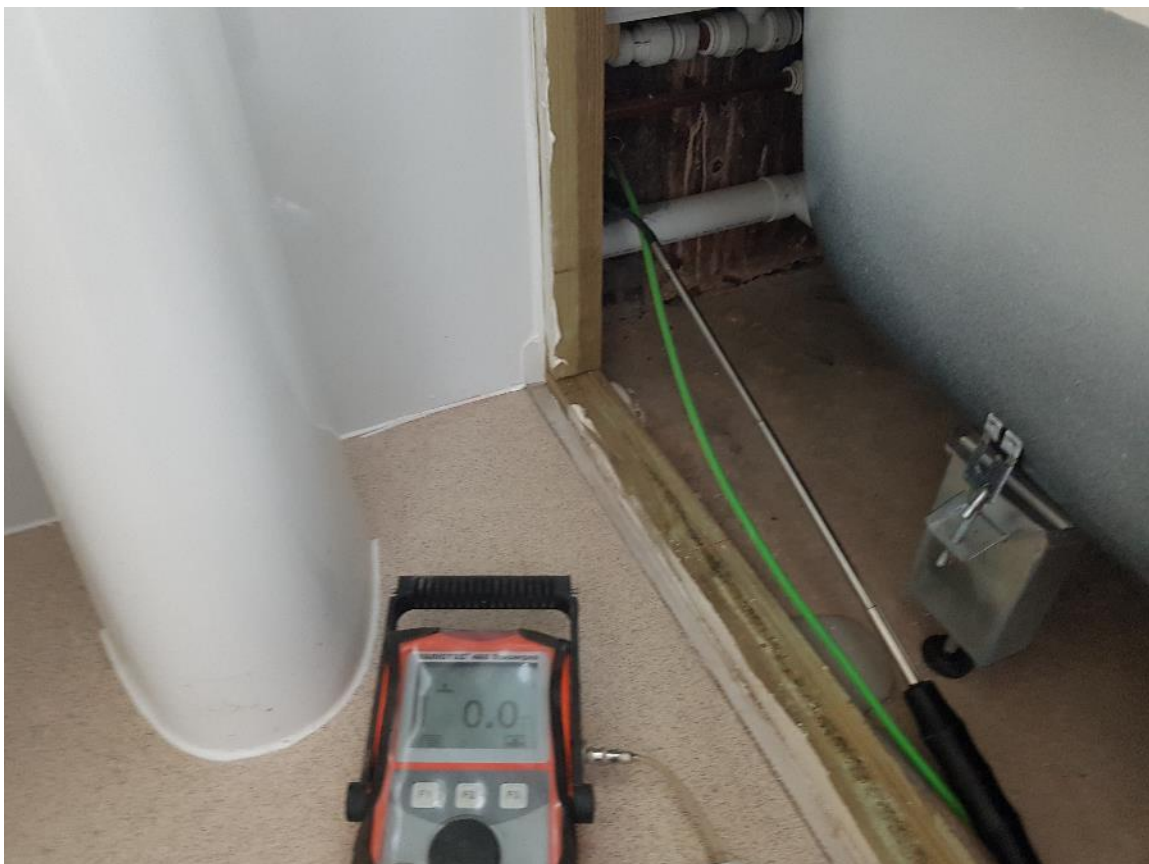
**No tracer gas found escaping**

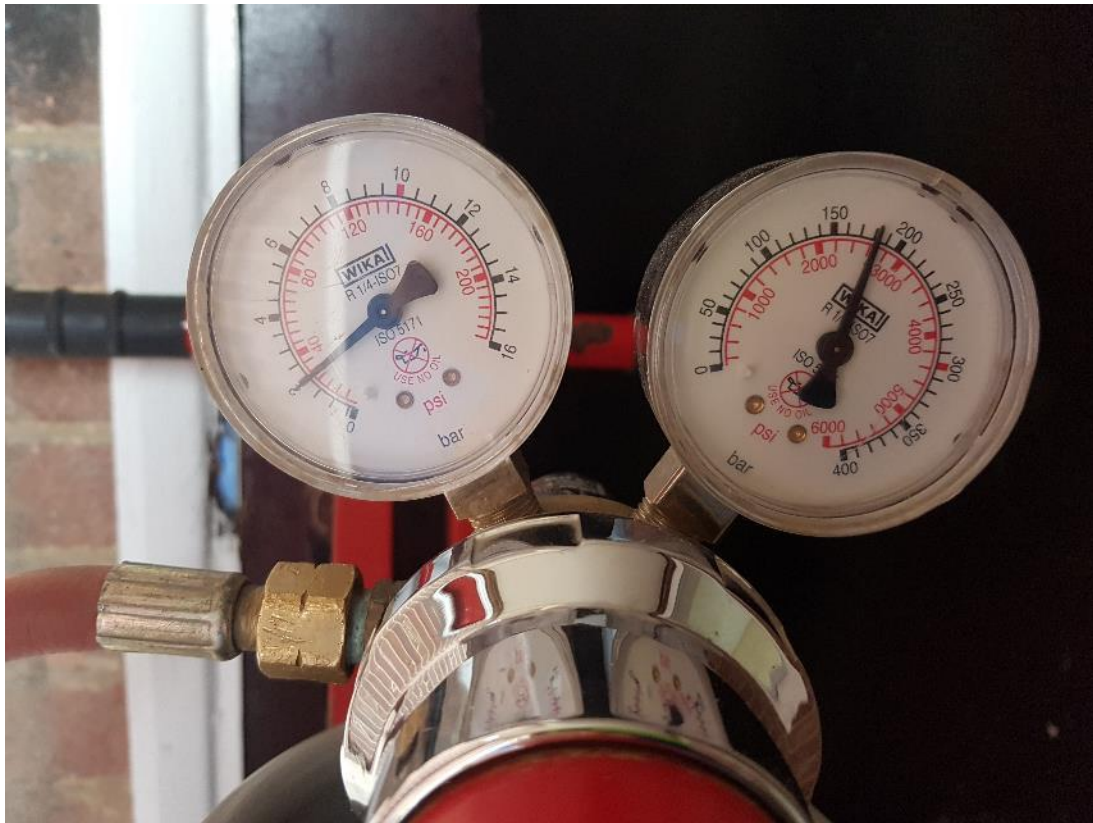
**No pressure loss identified**

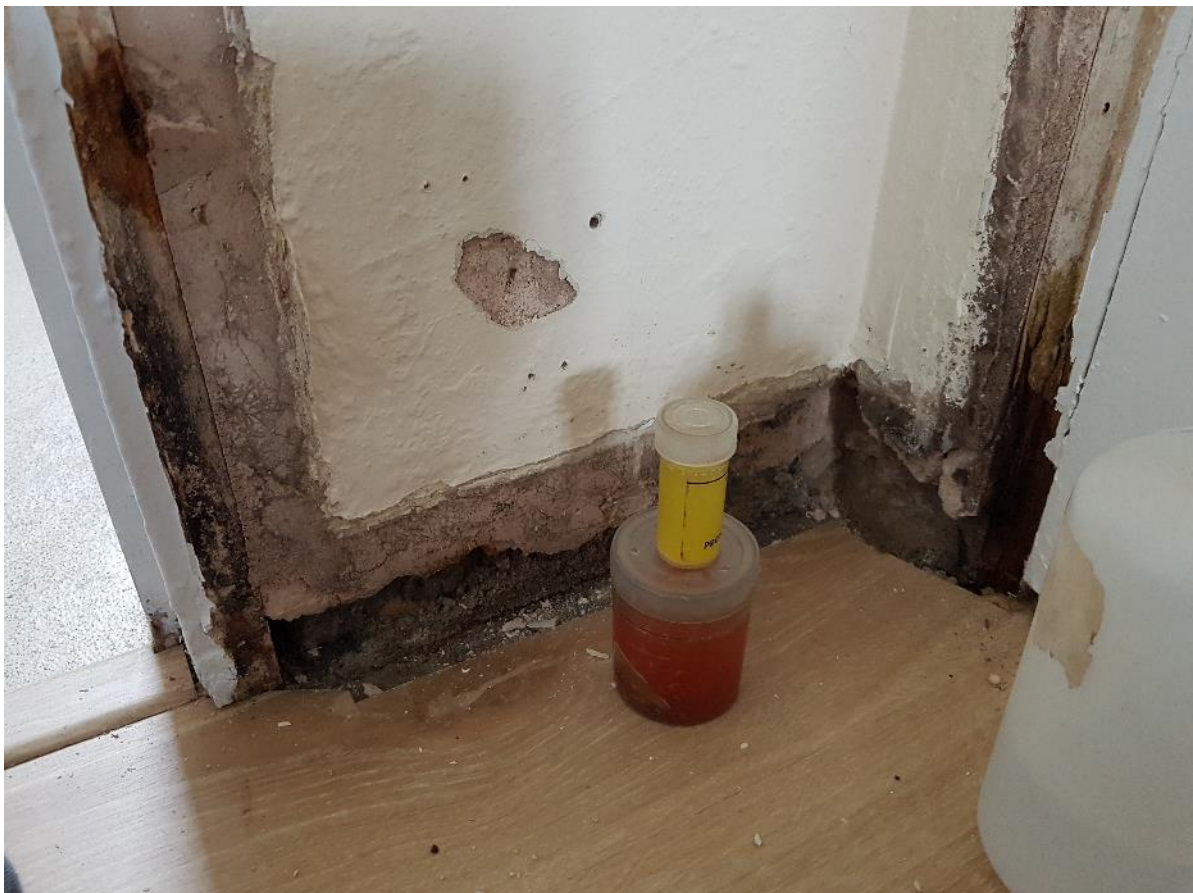
Salts sample at low level

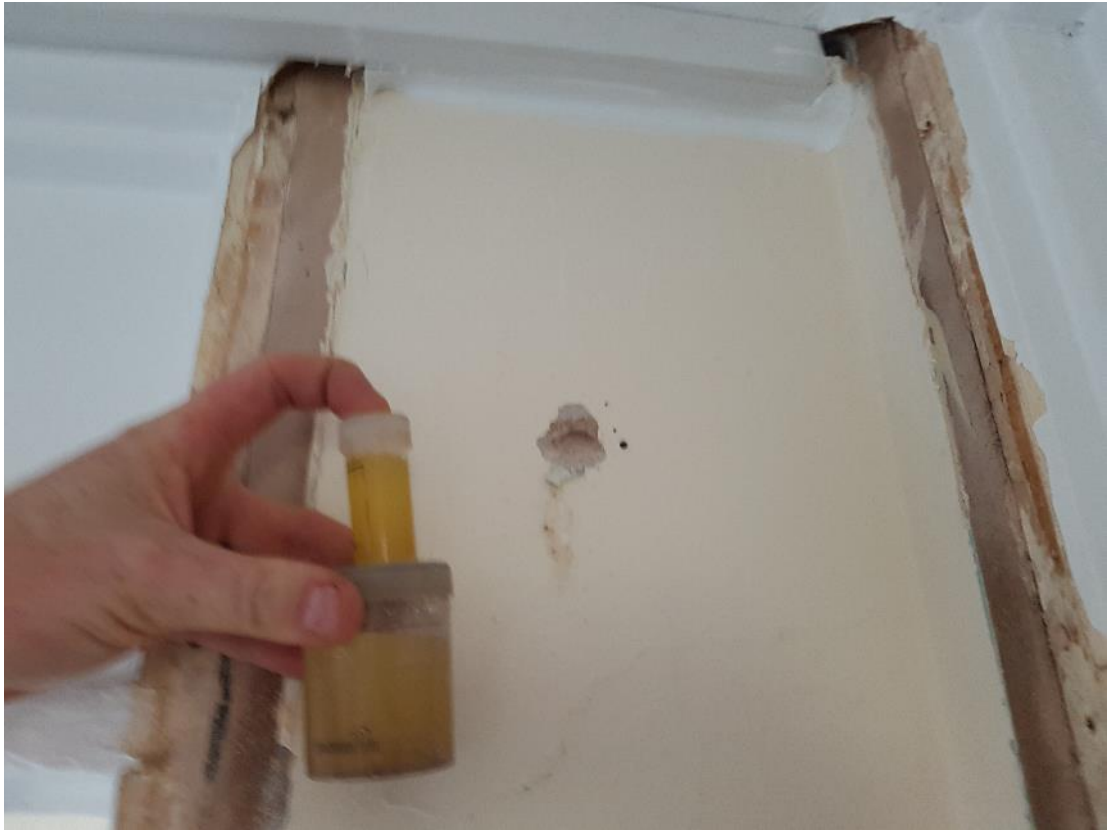
Salts sample results at high level

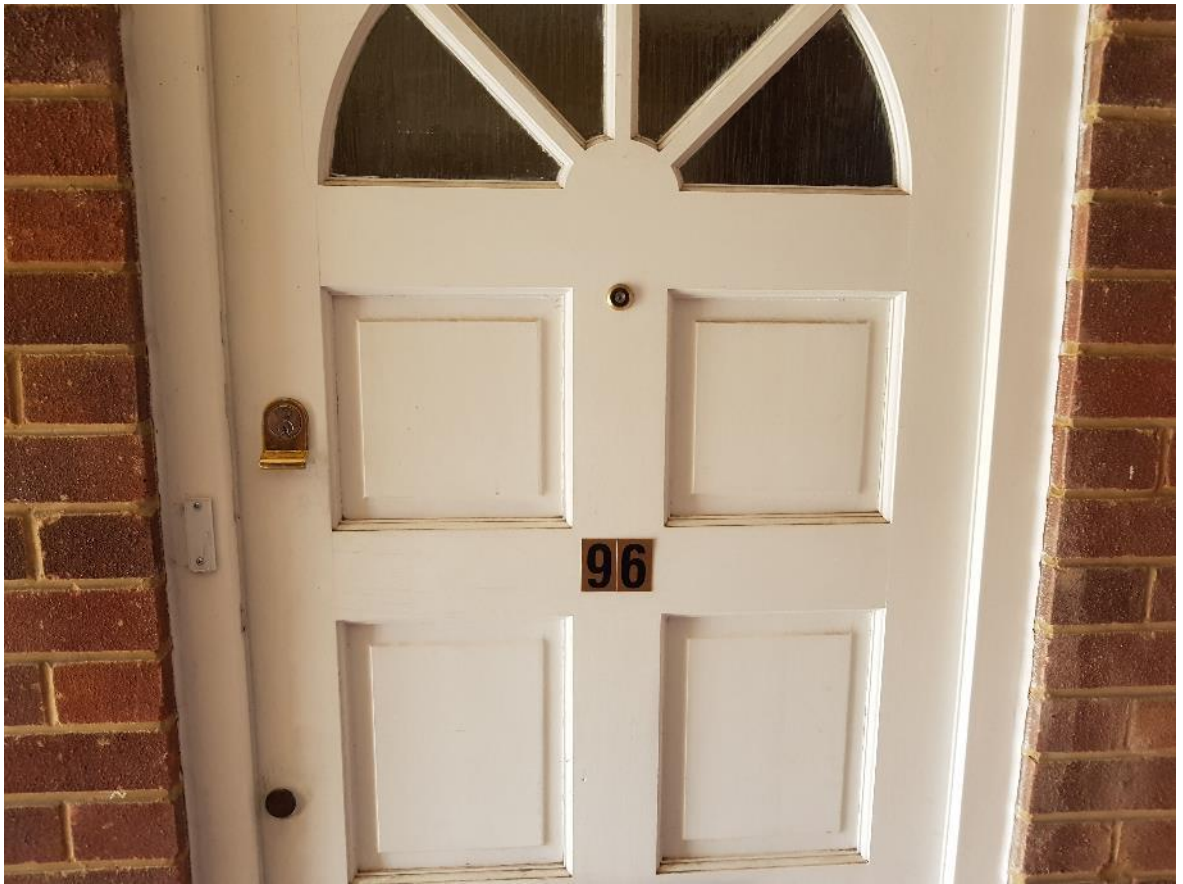
**No answer at property above**
