Residential Dust Analysis

Report Number: U508

LPD Lab Services Limited

Suzanne McLaughlin - West Berkshire Council

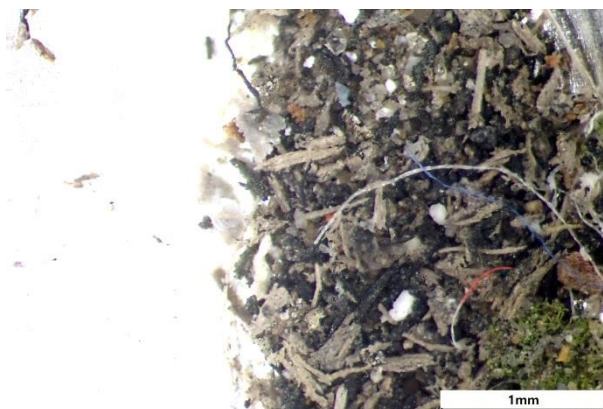
The dust collected in the foil showed a range of materials. There were many wood fibre fragments and some man-made fibres (white/blue and red) as shown in Figure 1 and Figure 2. There was also some moss like material (green) and many irregular shaped black particles.

Figure 1. Lower magnification optical image of sample LC1 as received in the aluminium foil.

Figure 2. Higher magnification optical image of sample LC1 as received in the aluminium foil.

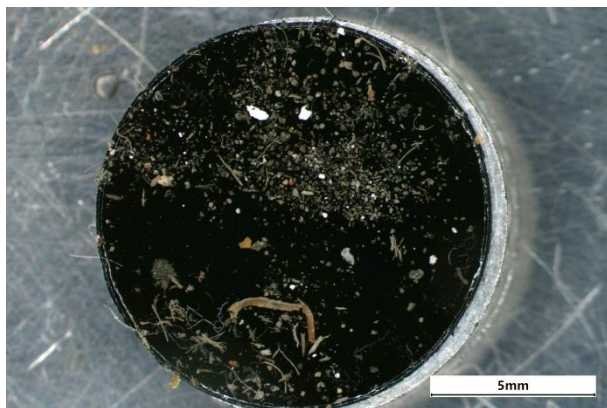
Figure 3. Lower magnification optical image of sample LC1 on the SEM stub.

Figure 4. Higher magnification optical image of sample LC1 on the SEM stub.

The sample LC1 also had angular inorganic particles of varying colour suggesting a mineral origin (Figure 4). The particles showed a range of colours from light grey, light brown and red - typical of building materials. Dispersed amongst these particles were black particles of around the same size.

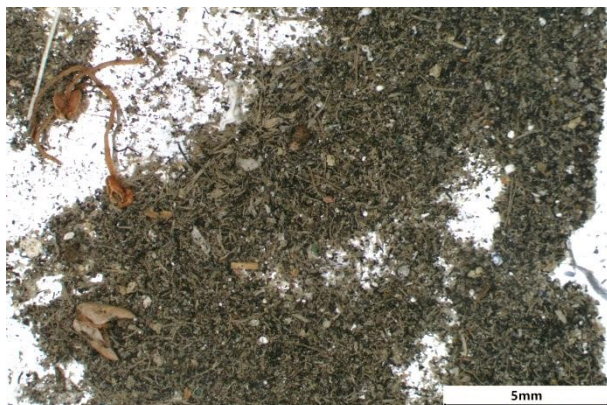
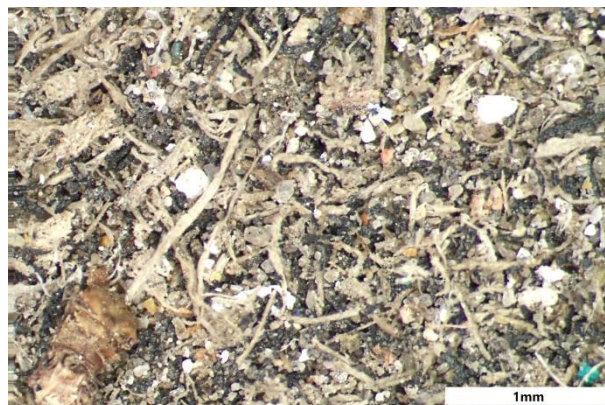
The LC2 sample was composed of many brown wood fibre particles (Figure 5 and Figure 6) and also many black particulates and some angular particles that appeared like inorganic mineral. There were bright white irregular shaped particles probably of man-made material (paint/plaster?).

Figure 5. Lower magnification optical image of sample LC2 as received in the aluminium foil.

Figure 6. Higher magnification optical image of sample LC2 as received in the aluminium foil.

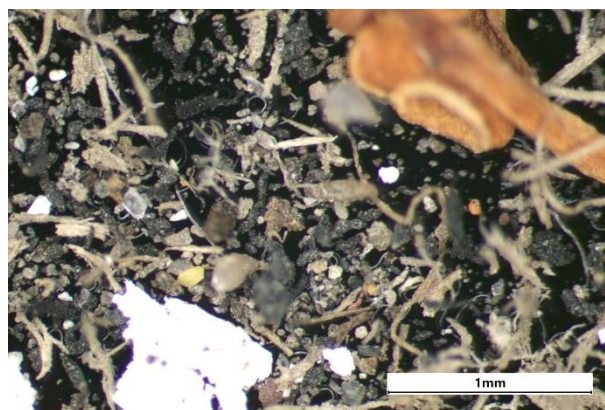
The large brown twisted 'fibres' evident in Figure 7 and Figure 8 (samples removed to SEM stubs) were natural in origin (possibly plant material).

Figure 7. Lower magnification optical image of sample LC2 on the SEM stub.

Figure 8. Higher magnification optical image of sample LC2 on the SEM stub.

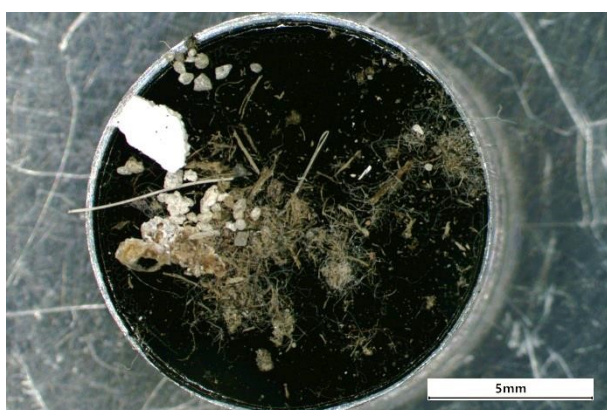
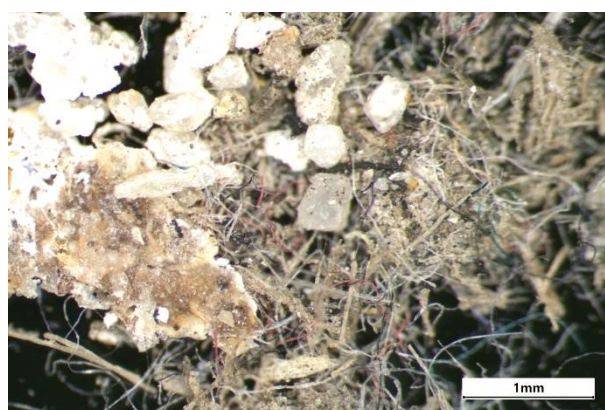
Figure 11. Lower magnification optical image of sample LC3 on the SEM stub.

Figure 12. Higher magnification optical image of sample LC3 on the SEM stub.

Concentrating the dust onto the SEM stub showed also that there were many fibres, cotton and man-made (Figure 12). The fibres had a range of colours from white, blue and red - typical of clothing. There were also very large flat

white particles seen which are indicative of white paint flakes or white painted plaster. Some angular particles on the SEM stub were also typical of building materials, being mineral in character.

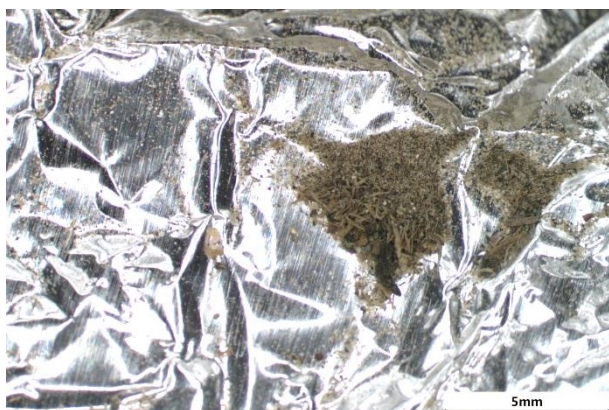
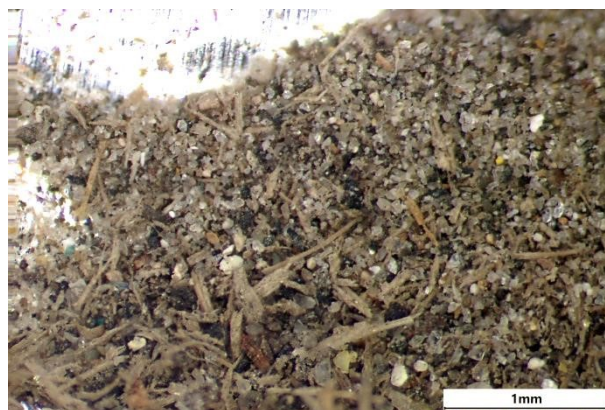
Dust sample LC4 showed an overall brown appearance, as seen in the low magnification optical image of Figure 13 and at higher magnification in Figure 14, showing many brown wood fibre fragments. Concentrating on the inorganic particles shown dispersed on the right-hand side of the SEM stub (Figure 15) appeared typical of particles generated from building materials (brick-work, cement/concrete), having a predominance of inorganic angular particles. There were black irregular particles dispersed throughout the sample.

Figure 13. Lower magnification optical image of sample LC4 as received in the aluminium foil.

Figure 14. Higher magnification optical image of sample LC4 as received in the aluminium foil.

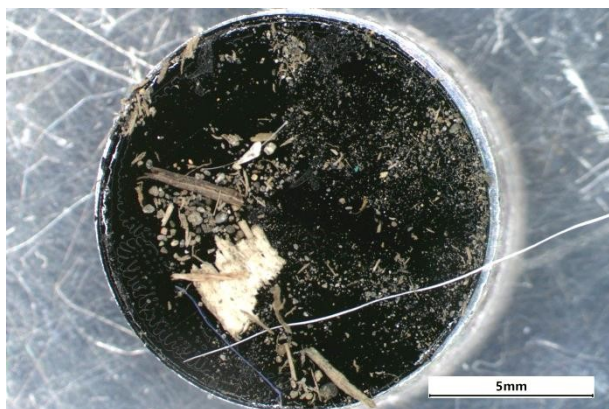
Figure 15. Lower magnification optical image of sample LC4 on the SEM stub.

Figure 16. Higher magnification optical image of sample LC4 on the SEM stub.

Large wood fibres were observed as well as some man-made fibres (blue and white, as shown in Figure 15, typical of clothing). The number of clothing-type fibres in this sample was very low compared to the other samples.

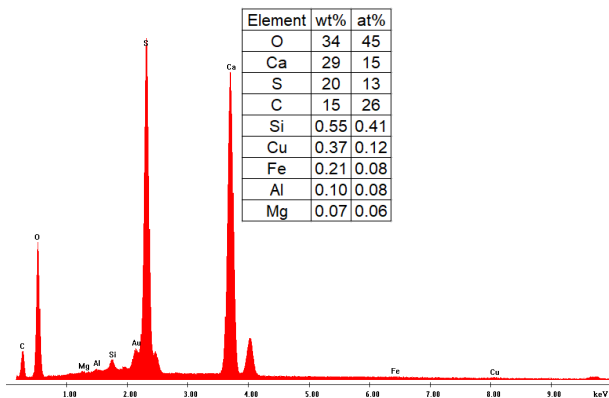
Figure 20 shows a higher magnification BSE image of particles 2 and 3 and Figure 21 and Figure 22, respectively, shows the EDX spectra and compositions of the analysed areas on the particles. Particle 2 consisted mainly of oxygen, calcium, sulphur and carbon and trace levels of other elements; this particle has a signature of mainly calcium sulphate (gypsum/plaster) with possibly some organic material (or possibly even calcium carbonate (limestone)). Gypsum or plaster particles are naturally very small (sub 10 µm in size) and so this particle represented a relatively large chunk of gypsum (plaster) particles.

Particle 3 consisted of mainly carbon, oxygen and silicon with trace levels of other elements. The angular mineral shape and EDX composition suggest that it was likely to be sand from building materials. Natural sand often has a silicon dioxide signature but with trace levels of other elements, but characteristically iron which gives sand its orange/brown colouration.

Figure 20. Higher magnification BSE image of particles 2 and 3 on sample LC1.

Figure 21. EDX spectrum and composition of particle 3 from sample LC1. Silica/sand signature.

Figure 22. EDX spectrum and composition of particle 2 from sample LC1. Calcium sulphate/gypsum/plaster signature.

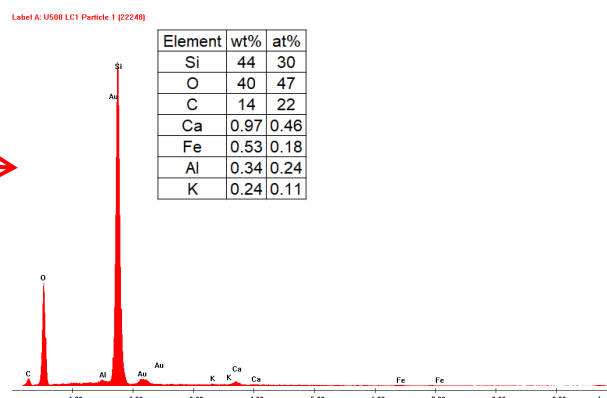
Figure 26 shows a higher magnification BSE image of particle 1, and Figure 27 shows the EDX spectrum/ composition of the analysed area. The angular mineral appearance of the particle and predominantly silicon and oxygen peaks indicated a sand/silica particle.

Figure 26. Higher magnification BSE image of particle 1 on sample LC2.

Figure 27. EDX spectrum and composition of particle 1 from sample LC2. Silica/sand signature.

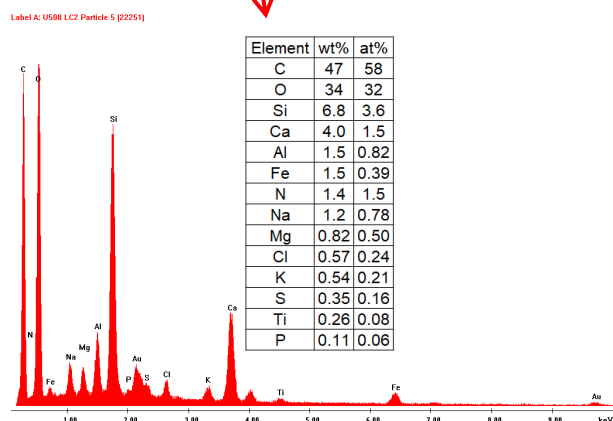
Figure 32 shows a higher magnification BSE image of particles 4 and 5. The EDX spectra and compositions of the analysed areas are shown in Figure 33 and Figure 34, respectively. Particle 4 consisted of carbon and oxygen with nitrogen, silicon, calcium, aluminium, iron, nitrogen and sodium and trace levels of other elements. The particle appeared as a flat scalloped surface with regular cut marks along its length. The particle was bright white and was likely to be a

silicone fragment with a decoration on its surface of organic material and elements associated with building materials (calcium alumina-silicate). Particle 4 consisted of carbon, oxygen and titanium with aluminium and trace levels of other elements. The high levels of titanium indicate titanium dioxide - a widely used whitener for paints and many man-made objects. The fibrous nature of the particle and presence of titanium would indicate a particle from a white-painted wood source.

Figure 32. Higher magnification BSE image of particles 4 and 5 on sample LC2.

Figure 33. EDX spectrum and composition of particle 4 from sample LC2.

Figure 34. EDX spectrum and composition of particle 5 from sample LC2.
