DESK STUDY SITE REVIEW FOR PROPOSED 3G FOOTBALL TURF PITCH (FTP) FEASIBILITY: Laurel Park, Lower Earley, Earley, Reading RG6 3DZ

The following is based on review of readily available records to inform a 3G FTP feasibility assessment and potential constraints associated with the ground. This review does not constitute a full risk assessment and should be confirmed and supported by ground investigations where appropriate.

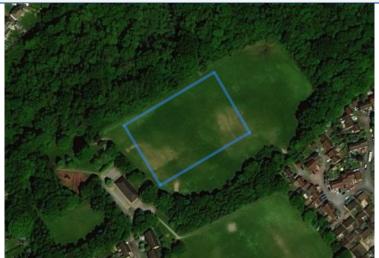
Suggested proposed position of 3G AGP (extent 112m x 76m) indicated by blue outline.

Potential for some significant level changes and uneven ground across the proposed footprint and therefore some cut and fill earthworks likely to be required, subject to topographical survey. Surrounded by mature trees/woodland which is likely to impact foundations on clay soils.
